MERRIMACK RIVER BASIN ALTON, NEW HAMPSHIRE

ALTON POWER DAM NH 00011

PHASE I INSPECTION REPORT

JANUARY 1980

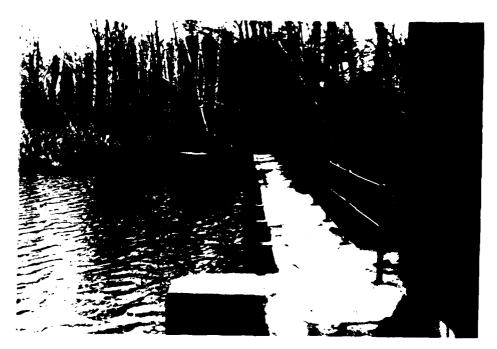
3. Alignment of dam from right abutment

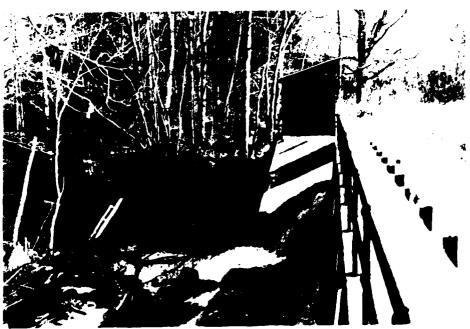
5. Right side of dam from footbridge

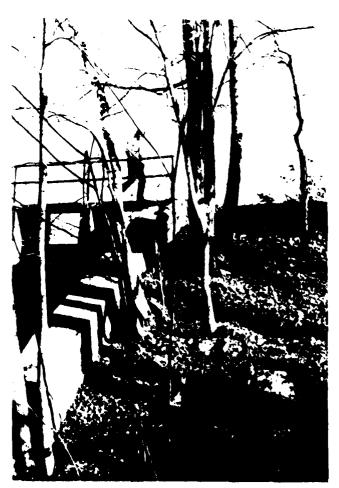
saplings and a number of trees up to 8 in. in diameter Along the upper portion of the left downstream slope are several large oaks, birch and small maple trees. A difference in grade was observed between the top downstream surface of the left training wall and the adjacent embankment, Photo No. 6. The embankment might have been constructed this way or the difference may be caused by natural settlement of the embankment due to insufficient compaction effort during its construction. Some minor erosion was also apparent along the downstream side and adjacent to the left training wall.

Left embankment adjacent to left training wall, downstream

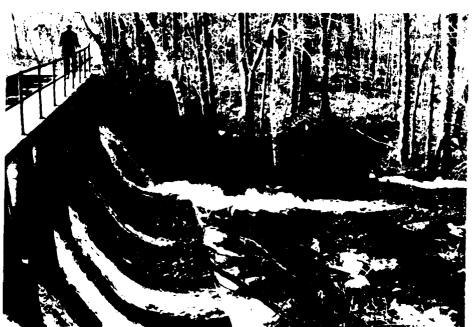
There was considerable seepage at the base of the old dry-laid stone wall located along the left side of the downstream channel, Photo No. 7. Seepage was also evident from 3 to 6 in. above the water level in the area left and downstream of the spillway left training wall, Photo No. 8. The water was clear. According to Mr. Franklin Alden, the seepage condition has been present for at least 20 years, although prior inspection reports, Appendix B, do not mention seepage

7. Old stone masonry wall, left training wall and embankment, downstream

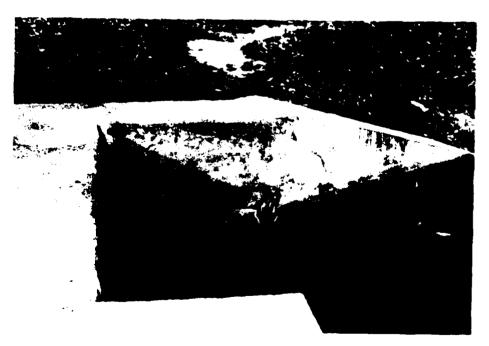
of the concrete at the outlet works intake headwalls, Photo No. 10, and cracking of the concrete at the downstream face of the outlet works. The section of steel penstock is about 33 ft. long and, though rusted, appears serviceable. However, concrete U-shaped footings located under the penstock have shifted and become displaced with time as shown in Photo No. 11. In turn, the footings give little or no support to the penstock.

10. Spalling concrete at right headwall, upstream

- a. Operation and Maintenance Procedures. The following should be undertaken by the Owner:
 - 1. Repair the spalled areas of concrete on the outlet works head walls and the cracks in the concrete, at the downstream face of the outlet works.
 - 2. Repair the timber stoplog supports.
 - 3. Cut and remove the trees and brush located on the crest and slopes of the left embankment. If the stumps are left in place or removed, with voids

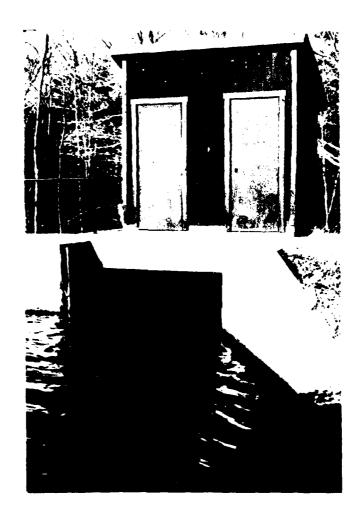
The gate lift mechanism, Photo No. 12, is enclosed by a wooden gate house which is also used to store spare stoplogs. Overall, the gate house was found to be in good condition as shown in Photo No. 13. However, the outlet works gate lift mechanism, when tried, could not be operated during the site examination. The Dam Operator reported that the gate was last opened sometime in 1972. The debris rack, originally located in front of the intake, has been removed at some unknown time.

13. Right headwall, gate house and outlet works intake, upstream
